**PROJECT** SLOW SAND FILTER REFURBISHMENT

Stonbury has recently completed the installation of a new floor and sandbar set during an ongoing project to increase the lifespan of a slow sand filter.

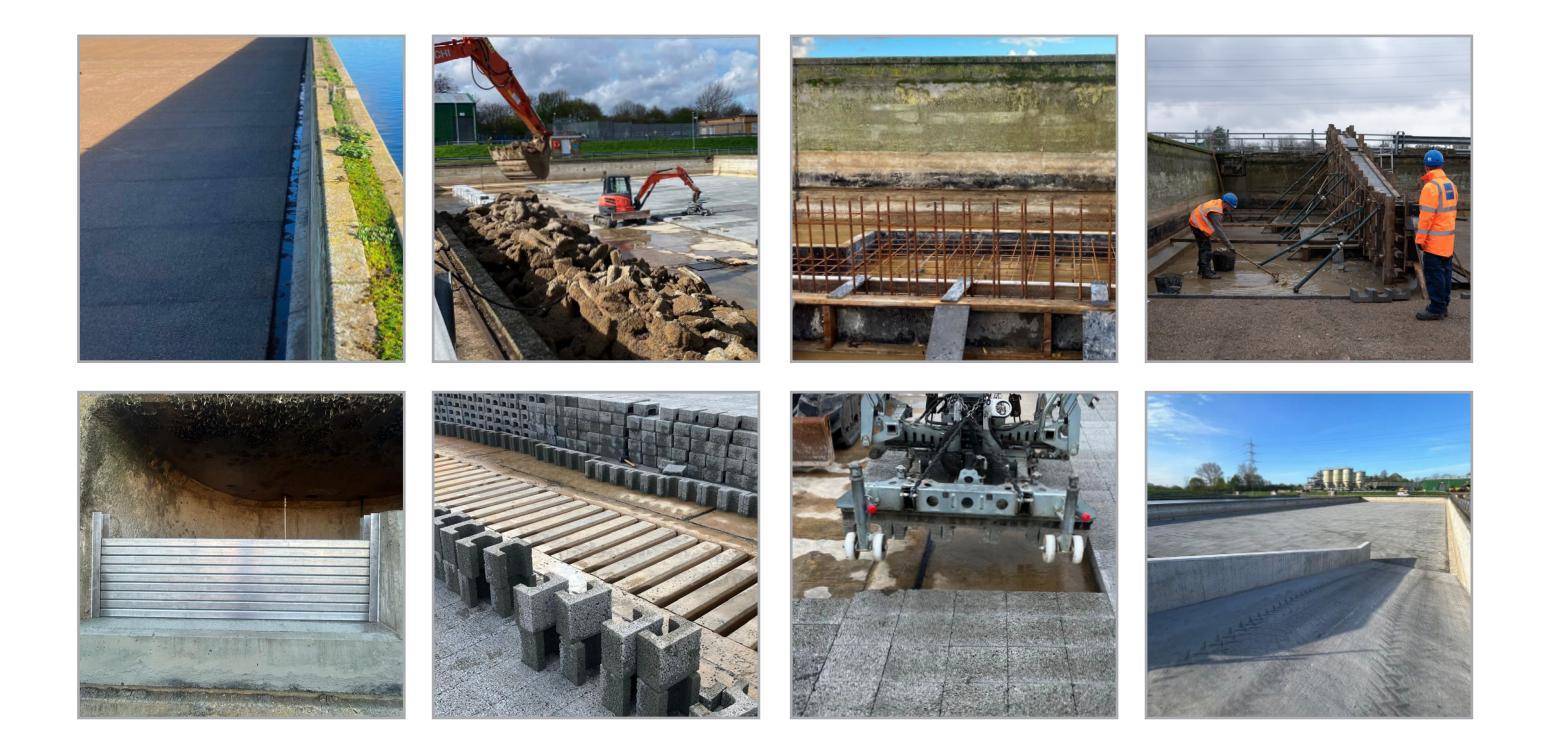
In this project, Stonbury removed the redundant porous concrete floor and replaced it with 67,000 new porous concrete blocks, offering greater cost-effectiveness, ease of installation and reduced embodied and lifecycle carbon compared with traditional poured concrete. The new block floor will allow for patch repairs to increase the longevity of the asset. The site team then installed new sandbars 600mm higher than the previous ones to enable a greater depth of sand and processing capacity. This involved re-building the concrete weir wall and replacing supporting components. The change will increase the skim life of the bed from around 80 days to 120 and significantly improve the lifespan of the sand bed.

Additionally, the refurbishment included wall and under-floor cleaning with high pressure water jetting, concrete repairs to the outer rim and the installation of a new ramp. To demonstrate thorough debris removal, Stonbury conducts a pre- and post-work CCTV camera survey on every asset.
